NASA CR-167966 PWA-5512-96

EXECUTIVE SUMMARY REPORT

JT9D JET ENGINE DIAGNOSTICS PROGRAM

UNITED TECHNOLOGIES CORPORATION Pratt & Whitney Aircraft Group Commercial Products Division

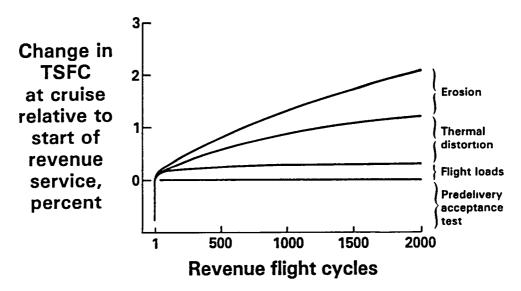
Long-term performance deterioration is also a flight cycle related phenomenon. It is caused by erosion of airfoils and gas-path seals during ground operation and take-off and by cyclic induced thermal distortion of the high-pressure turbine airfoils. Erosion primarily affects cold section efficiencies by blunting the blade leading edges, reducing airfoil chords, and further opening running clearances. Thermal distortion in the turbine results from high-temperature cycling with resultant gas-path leakage, loss of optimum airfoil shape, and further rubbing of seals. The effect of the long-term deterioration mode for the JT9D-7A engine is shown on Figure 1. An increase of 2 percent in cruise thrust specific fuel consumption is typical after 2000 flight cycles of revenue service due to performance loss in unrepaired engines.

Figure 1 JT9D-7A Engine Long-Term Performance Deterioration at Altitude Cruise Conditions Relative to Start of Revenue Service. (J21216-21)

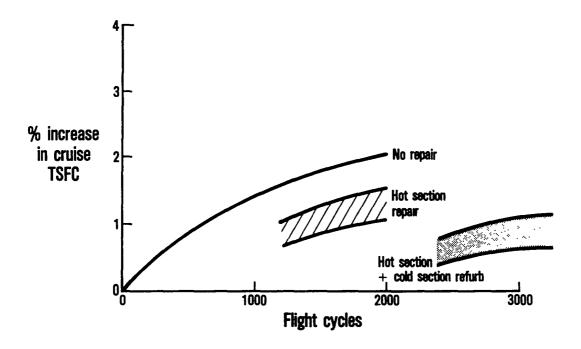
This NASA-sponsored program has identified possible approaches to reduce the short-term performance loss. It has also shown that performance retention within 1 to 2 percent of initial revenue service performance can be maintained with a proper program of hot section and cold section maintenance, as shown on Figure 2.

Figure 2 Effect of Repair on JT9D-7A Engine Cruise Thrust Specific Fuel Consumption. (J24603-24)

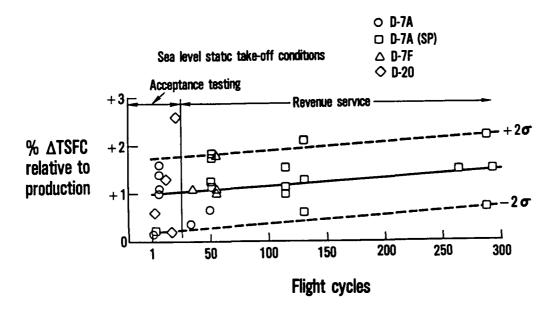
- o Performance deterioration trends may be divided into two distinct time periods: short-term and long-term deterioration. The prime causes of short-term deterioration are flight load—and engine power-induced rubs which open gas-path clearances, thus reducing module efficiencies and influencing airflow. The analysis of the historical data as seen on Figure 3 showed an initial increase in thrust specific fuel consumption at sea level in the first few flights conducted by the airframe manufacturer, prior to delivery of the airplane to the airlines.

Figure 3 Historical Short-Term Deterioration Data. (J24873-4)

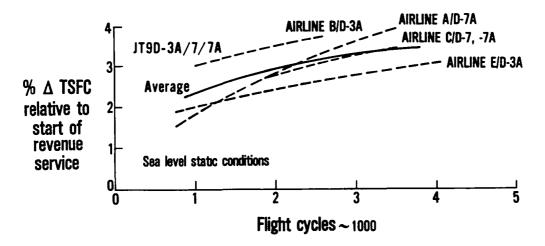
- o The long-term performance deterioration then occurs at a slower rate with the dominant causes being erosion in the cold section and thermal distortion of airfoils and seals in the hot section, Figure 4. Both these effects are also cyclic functions.

Figure 4 Historical Long-Term Deterioration Data for Unrepaired Engines. (J24603-8)

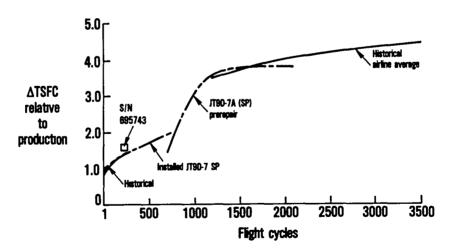
The first task of the program provided an abundance of information (Reference 1), but it left numerous gaps in the data. The second task. an in-service engine performance study, conducted jointly with Pan American World Airways, expanded the data base significantly by -allowing the monitoring of a controlled sample of 28 JT9D-7A engines in the Pan American 747SP airplane fleet from preflight testing of the engines at Boeing through 2100 flight cycles of operation (Reference collection included: 2). The data installed-engine calibrations before the first airplane flight and periodically during subsequent revenue service; in-flight engine calibrations during the flights immediately following the ground calibrations; a complete set of crew-collected engine condition-monitoring data from the fleet; prerepair and postrepair calibrations; and repair histories on each of these engines that came into the shop (Reference 3). The data also included an expanded instrumentation calibration and a complete analytical teardown of one of the engines (S/N 695743) after 141 flight cycles (see Figure 5).

Figure 5 Pan American 747SP/JT9D-7A In-Service Engine Performance Data. (J24873-6)

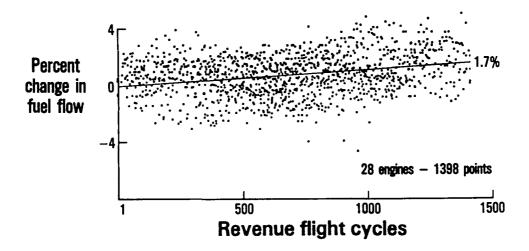
The results of this effort firmly established that the load-induced short-term deterioration occurs in the first few flights prior to revenue service. The study provided data for the refinement of the various engine module deterioration prediction models which were first developed on the basis of the historical data. Finally, the study provided a correlation between performance retention at flight cruise conditions and performance change as measured by ground calibrations. The quality of the flight performance data was less than that of the ground tests due to the limitations of available instrumentation systems. However, the data sample was large enough that statistical trends could be established. One such set of data is 747SP engine condition monitoring (ECM) fuel flow data shown in Figure 6. The data were recorded at cruise altitudes between 32,000 and 40,000 feet and corrected to 35,000 feet and constant engine pressure ratio (EPR). A trend line through the 1398 data points shows a 1.7 percent increase in fuel flow rate after 1500 revenue flight cycles from the start of airline service on engines with no repairs.

Figure 6 Cruise Fuel Flow Trend with Usage for Pan American 747SP/JT9D-7A Unrepaired engines. (J24873-7)

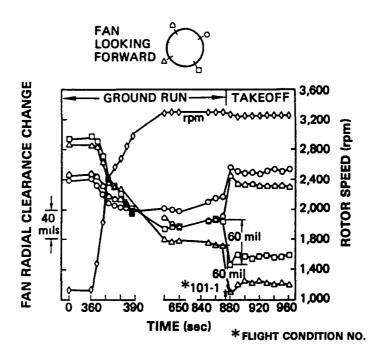
Analysis of these load and clearance closure data verified the importance of aerodynamic loads and added new information to the short-term deterioration evaluation. Aerodynamic loads were shown to be a function of the airflow into the engine inlet and the degree of bending of that air stream to enter the inlet. These aerodynamic loads were found to be larger than predicted. Thus, maximum aerodynamic loads occurred under conditions combining high power and high airplane angle of attack. The aerodynamic load was the dominant effect on fan clearance; thus, the critical fan operating condition was at take-off. Figure II shows the change in fan clearance during ground idle, acceleration to full power, rolling down the runway, take-off, and climb for each of the four laser clearance-measuring probe locations. The initial acceleration causes greater closure at the bottom of the engine since the centrifugal and thrust bending effects are additive.

Figure 11 Change in Fan Running Clearance from Stabilized Idle to Take-Off at 612,000 pounds TOGW with 20-degree Flaps.

At take-off rotation the aerodynamic load builds up causing an upward deflection of the inlet, resulting in further closing of clearances at the bottom and clearance opening at the top. Closure was greater at take-off with 10-degree flaps and at high gross weights as a result of the higher aerodynamic loads.

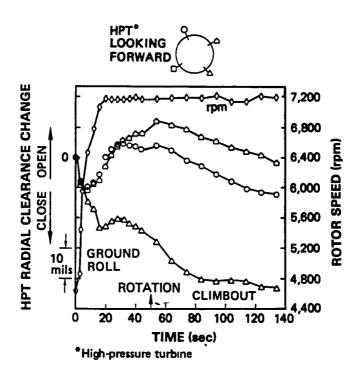
The maximum clearance closure in the high-pressure turbine was shown to be the result of a combination of effects. Centrifugal expansion, thrust and aerodynamic load-induced case bending, and differential thermal expansion all combined to close down running clearances. Thus, during the typical revenue flight cycle, maximum turbine clearance closure occurred during early climb when the aerodynamic loads were still reasonably high and thermal equilibrium had not been reached. Figure 12 shows that centrifugal expansion, thrust loading, and blade and case thermal expansion initially closed the running clearance as power was increased. Aerodynamic loads at take-off closed the clearance an additional 5 mils at the bottom of the engine. However, the slow thermal expansion of the rotor disk continued the axisymmetric closure for an additional 4 minutes. The maximum closure increased slightly with greater take-off gross weight.

Figure 12 Change in High-Pressure Turbine Clearance from Ground Roll to Take-Off at 571,000 pounds TOGW with 10-degree Flaps.

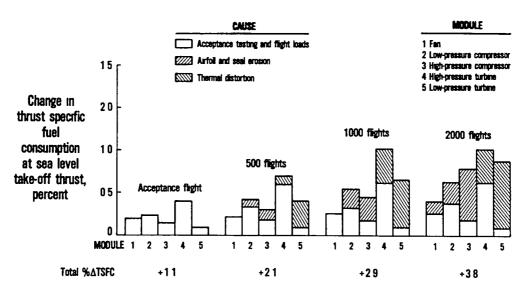
analytical-model Figure 13 shows the predicted performance deterioration at sea level for an average JT9D-7 engine, by module contribution and by cause. The model includes the production acceptance test loss which occurs prior to airplane delivery. model also assumes no engine repairs with the exception that the high-pressure turbine has been stabilized at a constant level after 1000 flight cycles by a hot section maintenance program. As seen, the low-pressure compressor and high-pressure turbine are most sensitive to early rub-induced deterioration. Erosion of airfoils and seals is the prime contributor to long-term deterioration in the engine cold section as shown on Figure 13, while thermal distortion is the prime contributor in the hot section.

Figure 13 Predicted Performance Deterioration at Sea Level Relative to Production Engines by Module Contribution and by Cause.
(J26090-15)
